# MONUMENT RECORD

D-16

STATE OF INDIANA - COUNTY OF MONROE

Section Nineteen (19), Township 9 North, Range 1 East

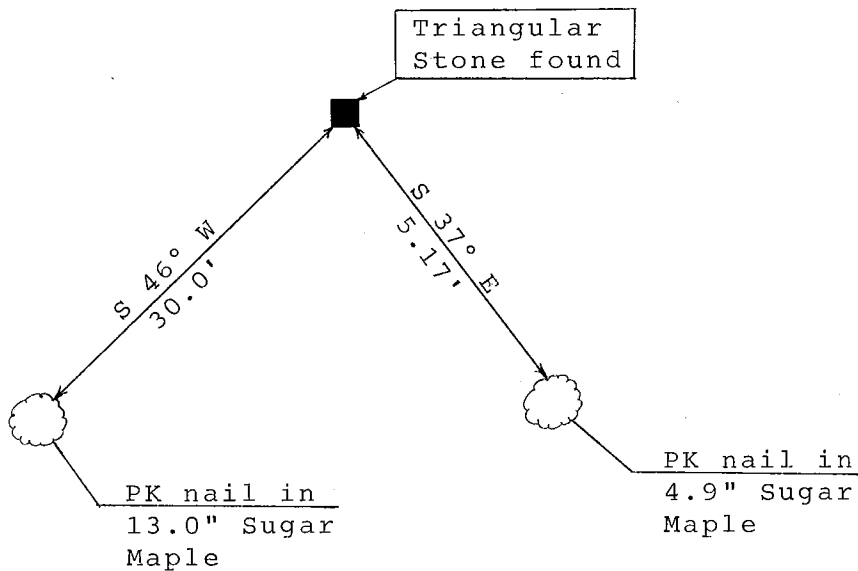
Recovery Tie Drawing

Monument Description & Remarks: Stone found in bottomland at NW Corner of  
SE 1/4 of SE 1/4. Stone was triangular, 5" x 5", 3" exposed w/barbwire  
adjacent. Corner witnessed 1/11/90.

Stone, triangular in shape, roughly 5" by 5" exposed 3" with barbwire adjacent.

04.9" SUM 5'2" at 143° 53' 37" E 11:36 am, clear, windy, 40°; measurements from Stone  
13.0" SUM 30'0" at 226° 54' 10" W to PK nail w/pink flagging in base of tree.
